DETERIORATION OF BUILDING CERAMICS BY ENVIRONMENTAL FACTORS - A CASE STUDY ON ZSOLNAY CERAMICS FROM THE MUSEUM OF APPLIED ARTS (BUDAPEST)

ÁGNES BARICZA¹, BERNADETT BAJNÓCZI², MÁRIA TÓTH³, CSABA SZABÓ⁴

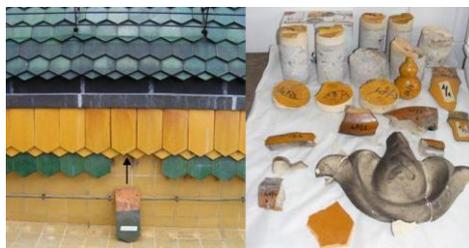
The sampled ceramics are pyrogranite decorative objects, unglazed and glazed roof tiles. The role of the glaze layer is to decorate and protect the ceramic body. The ceramics were manufactured by one of the leading ceramic factories in Hungary, Zsolnay Porcelain Manufacturer. Since the construction of the Museum in 1896 the ceramic tiles and pyrogranite elements suffered numerous environmental and human influences therefore, the objects were damaged and from time to time had to be replaced. During sampling we collected ceramics of different ages (i.e. from different renovation periods) and with diverse glazes covered by a thick black deposition layer (Fig. 2).

Figure 2. A green glazed tile from the roof of the the Museum of Applied Arts (on the left) and the studied samples of pyrogranite elements (on the right)

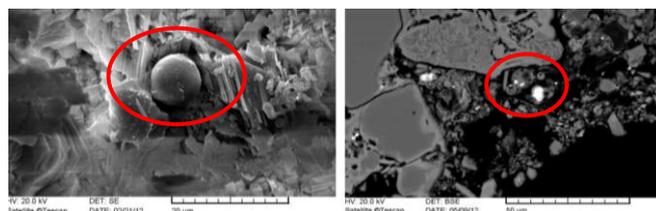
The tiles, depending on their exposure, are covered by a grey-black deposition (contamination) layer, which firmly adheres to the surface. The deposition layer contains dust, soot and aerosols in variable quantity. Different types of spherules often appear on it, occurring on the glazed and the unglazed back sides of the tiles (Fig. 3). Fe-rich, silicate spherules and spherules with complex composition, containing Si, Ca, K, Al and S, can be distinguished, which are natural or artificial in origin. We also observed artificial

carbonaceous forms. The artificial spherules probably originated from fossil fuel (coal and oil) combustion [6], thus they are generated by industry and other human activities (e.g. heating).

Figure 3. Scanning electron microscope pictures of natural and artificial spherules. 20 µm wide natural spherule with complex composition (Si, Fe, Ca, Al rich) in compact gypsum crust on the glazed side of a ceramic tile (on the left) (SE image) and a bright Fe-rich and several dark, carbonaceous artificial, 5-15 µm sized (in diameters) spherules in the dust layer on the unglazed (back) side of a ceramic tile (on the right) (BSE image)
